**DEPARTMENT OF TRANSPORTATION****DIVISION OF ENGINEERING SERVICES**

Contract #: 04-0120F4Cty: SF/ALA Rte: 80 PM: 13.2/13.9File #: 69.15**SOURCE INSPECTION REPORT****Resident Engineer:**Pursell, Gary**Address:** 333 Burma Road**City:** Oakland, CA 94607**Report No:** SIR-000600**Date Inspected:** 04-May-2009**Project Name:** SAS Superstructure**OSM Arrival Time:** 0**Prime Contractor:** American Bridge/Fluor Enterprises, a JV**OSM Departure Time:** 12**Contractor:** Zhenhua Port Machinery Company, Ltd (ZPMC), Changxing Island**Location:** Changxing Dao, Shanghai

**OBG 2AW**

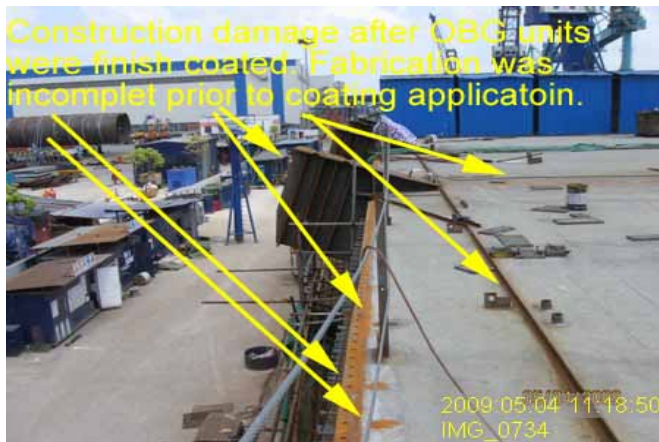
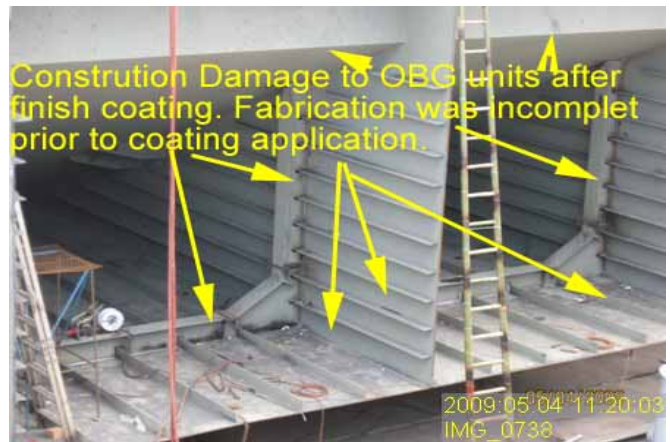
ABF Paint Supervisor Bill Oak arranged a walk through of the OBG Lift Assembly Area with ZPMC's Manufacture Department Director Engineer, Zhu Qi Jiang to make him aware of the amount of coating damage being inflicted after finish coatings have been applied during assembly. He was not happy with what he saw and said he would contact the fabrication department. Caltrans QA Coatings Inspector Jordan and Caltrans Structural Materials Representative (SMR) Andrew Ferng were invited to accompany Mr. Oak and Mr. Jiang. Mr. Jordan and Mr. Ferng gratefully accepted the invitation.

Fabrication on assembled components of the OBG's are not complete. Coating damage requiring re-blast is expected.
